## COMBINATION AIR VALVE FOR WASTEWATER MODEL D-065

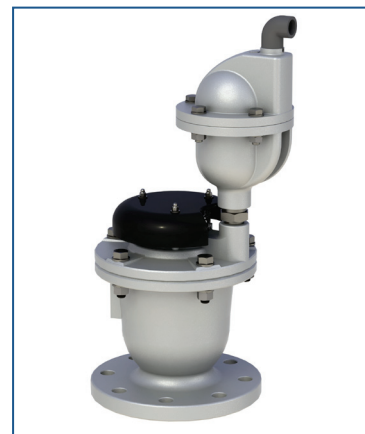
- A.1 The air valve will be mounted on a riser, connected to the **top** of the pipe.
- A.2 An isolating valve will be installed below the air valve.
