## COMBINATION AIR VALVE FOR WASTEWATER MODEL D-065M1

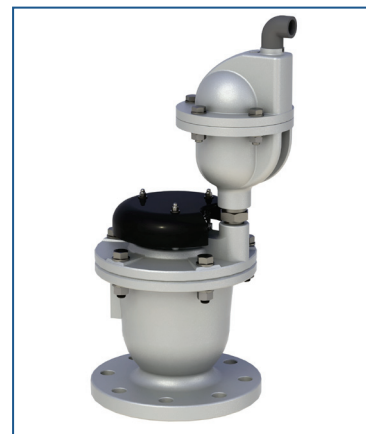
- A.1 The air valve will be mounted on a riser, connected to the **top** of the pipe.
- A.2 An isolating valve will be installed below the air valve.

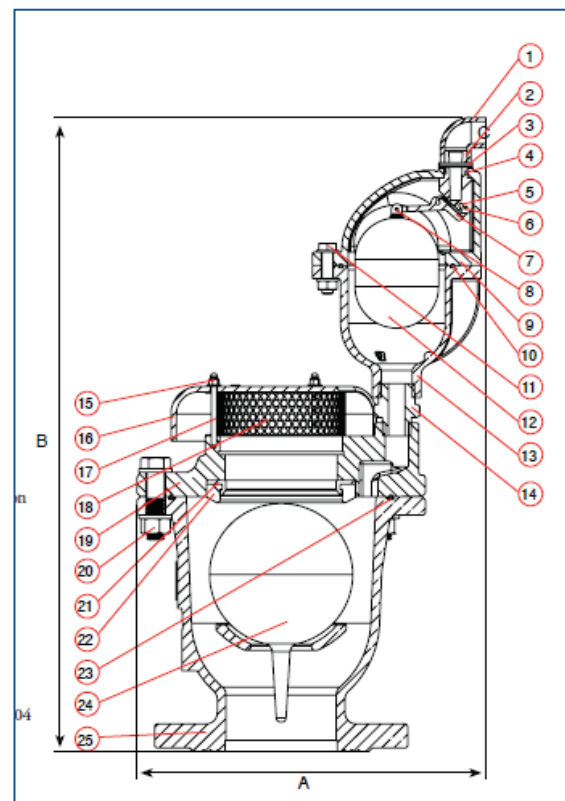
- B.2 Slowly open cover bolts (11) alternately until water and air start to be released. Wait until all the water and air cease to be released before removing the cover and bolts.
- B.3 Remove the discharge outlet (1) attached to the cover (2) .
- B.4 Wash and clean the air discharge orifice (4) with water .
- B.5 Wash the rolling seal (7) and make sure that is not torn or cracked.
- B.6 Wash the float (12) making sure to remove coarse grime or accumulated scale.
- B.7 Wash the valve body (13) and remove any coarse grime or scale clinging to the sides.

- B.8 Make sure the O-ring (10) is intact and situated fully inside the body groove.
- B.9 Make sure that the center of the lever (7) is in the center of the cover, and the Roll pin (5) is well attached to the plastic orifice (6).
- B.10 Replace the lid and tighten the screws and bolts.

- B.11 Unscrew the Bolts and Nuts (20) that connect the valve Cover (19) to the air valve Body (25).
- B.12 Wash the air valve Body (25) , the Screen (18) and the Cover (19) in clean water in order to remove coarse grime or accumulated scale.
- B.13 Reinstall in reverse order and fasten and tighten all the Bolts and Nuts (20).
- B.14 Open the isolating valve and make sure that air is being released from the air release valve orifice.
- B.15 Replace the discharge outlet (1) by clicking into place.
- B.16 Make sure there are no leaks from the air valve
